MERCURY IN AN ENCLOSED CHAMBER
AS A HIGH SPEED ELECTRICAL CONTACT

C. E. OLSEN
AND
J. H. FISHER

Submitted in partial fulfillment
of the requirements
for the degree of
MASTER OF SCIENCE
IN
ELECTRICAL ENGINEERING

United States Naval Postgraduate School
Monterey, California
1953

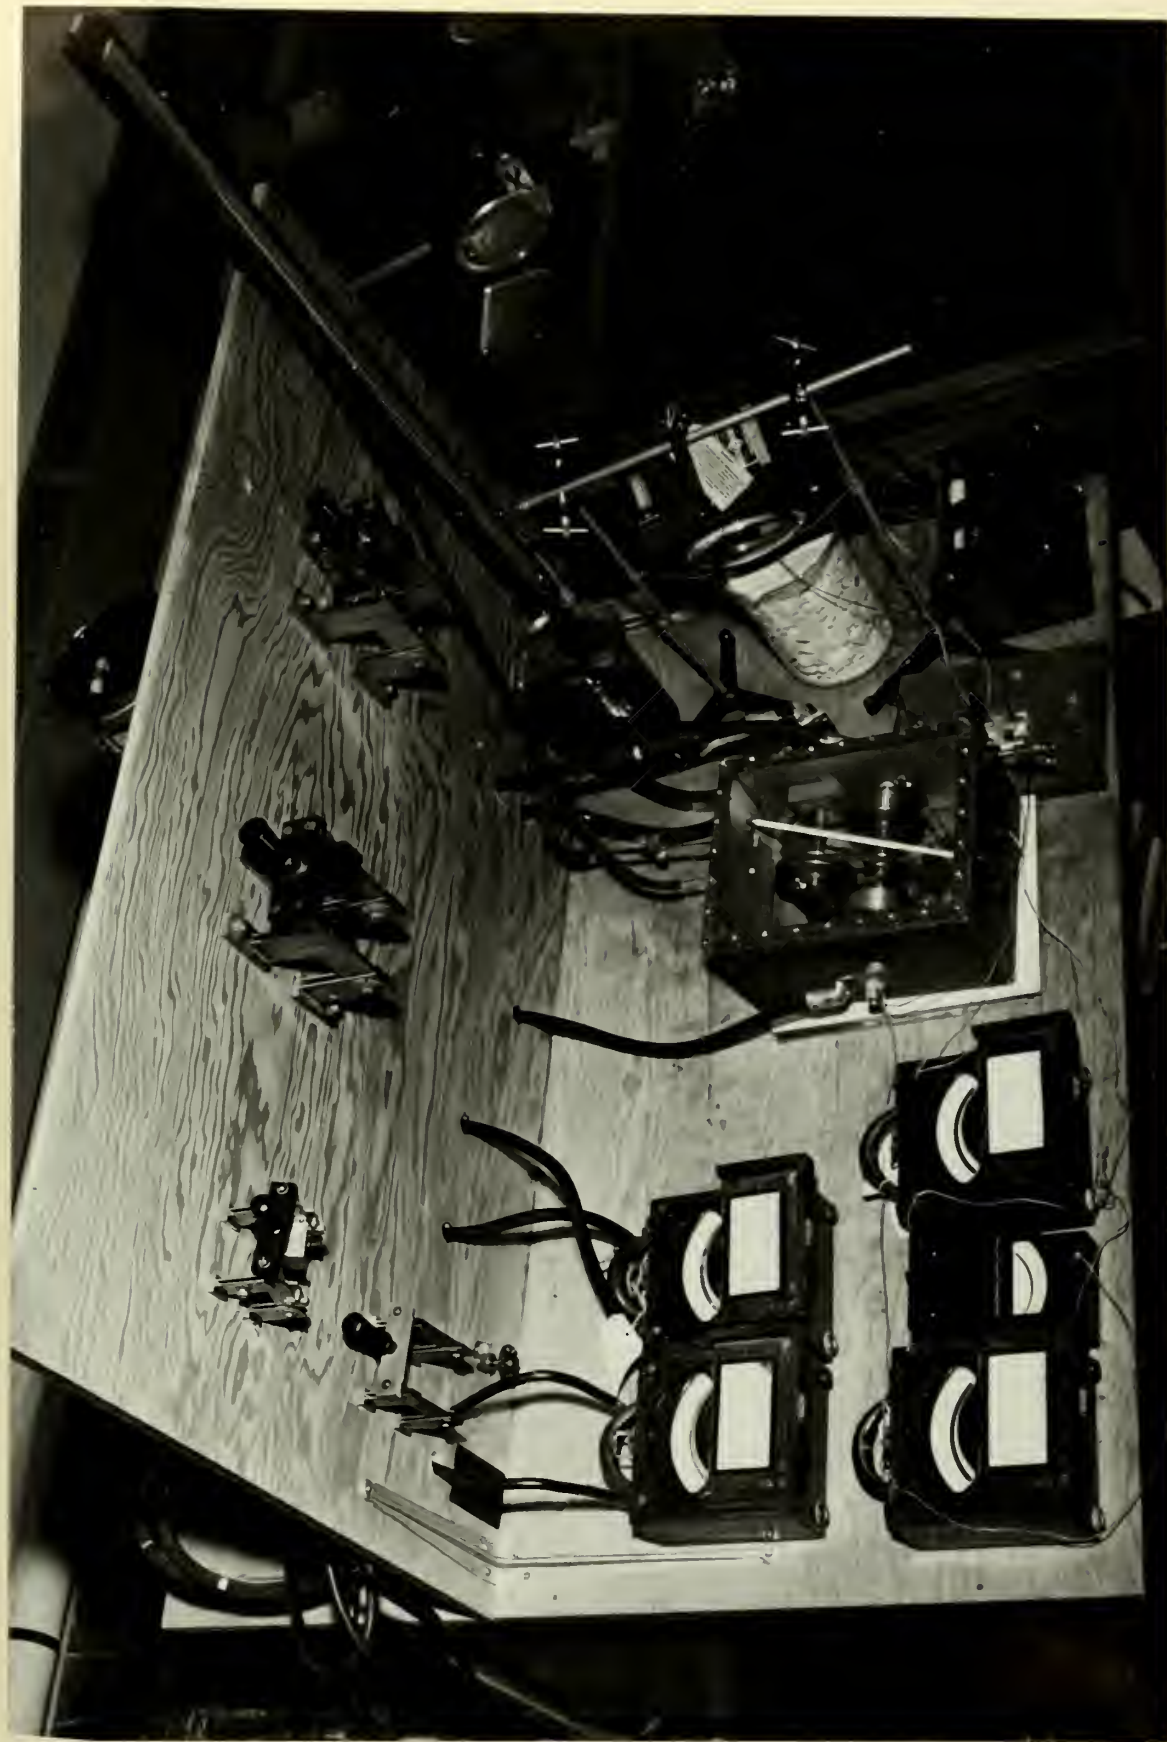
Fig. 12

Test Apparatus (Oblique View)
